SEVEN YEAR DATA FOR TEN YEAR PROLENE STUDY: ERF 85-219

Interim report on the physical testing of PROLENE, PVDF, ETHILON & NOVAFIL after seven year subcutaneous implantation in the Beagle Dogs - TEN YEAR BSR STUDY, ST#E211-92, 85-219

TEN YEAR PROLENE BSR STUDY 7-YEAR DATA SUMMARY

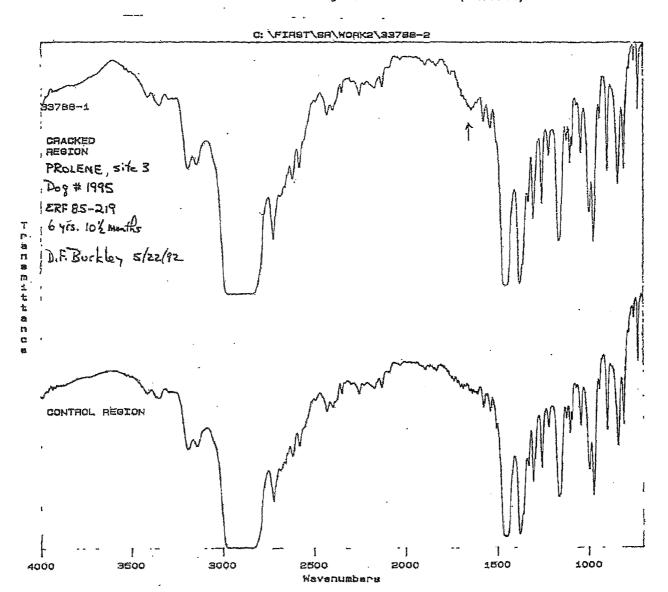
Figure A - Comparison IR Spectra of Cracked and Non-cracked Regions of PROLENE (SR33788)

IR microspectroscopy was used to examine cracked areas in ETHILON, Novafil and PROLENE $^{\text{\tiny{N}}}$ explants. IR spectra obtained for cracked PROLENE specimens (Figure A) showed possible evidence of slight oxidation (a broadened weak absorbance at about 1650 cm-1). spectra obtained for cracked areas of ETHILON and Novafil did not differ from uncracked areas (Figures B and C), but expected IR absorbances for oxidation would be masked by the strong carbonyl absorbances normally observed for these sutures. Figures D and E show pictures of the areas examined by IR microspectroscopy for ETHILON and Novafil.
